ANNEX D

High Hazard Potential Dams

ANNEX D: HIGH HAZARD POTENTIAL DAMS

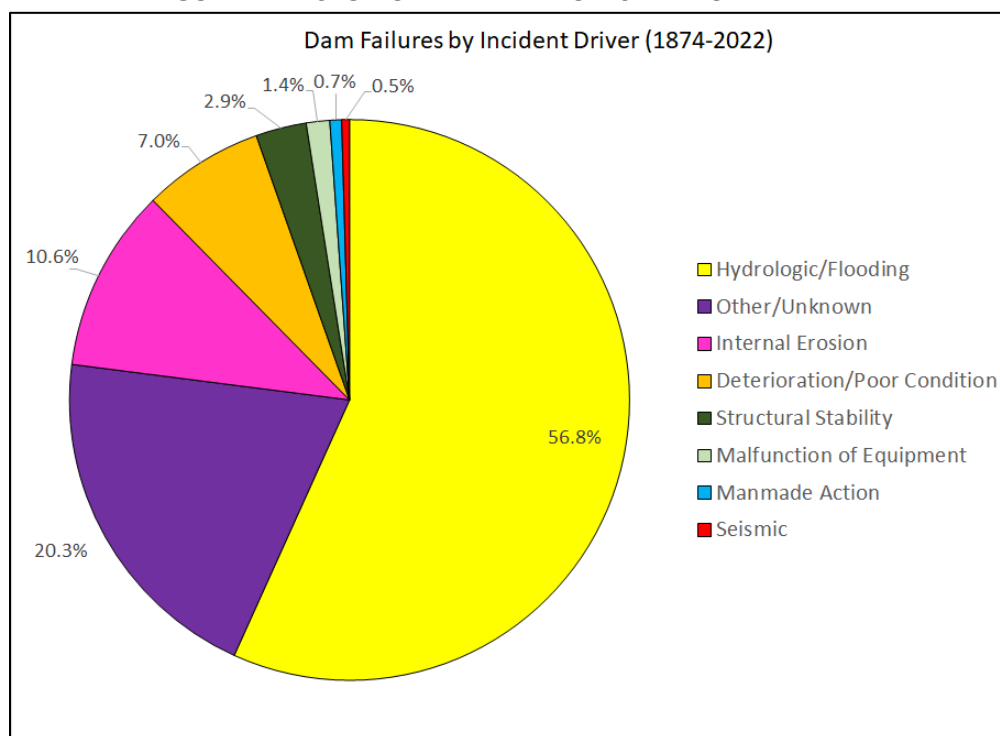
FIGURE 4: HISTORICAL DAM FAILURES BY INCIDENT DRIVER

The Association of State Dam Safety Officials (ASDSO) provides a database of recorded dam failures in the United States since 1874 and the attributed driving force behind these failures. From this database, last updated in February 2023, there are 9 categories of “Incident Drivers” that led to a recorded dam failure in the United States. **FIGURE 4**, below, provides a breakdown of the 444 dam failures.

From the historical database of dam failure incidents maintained by ASDSO (**FIGURE 4**), of the three dam failures attributed to "Manmade Action," none make any indication that an act of vandalism or terrorism was associated with the dam failures; however, there is a large category of "Unknown" dam failures (nearly 20%) where little information is known as to the cause of the incident. It is likely the hazard posed by vandalism and terrorism is under-reported, as all trace of any malicious actions are likely lost following an incident, and very few dams, even HHPDs, maintain a human presence and/or security system to monitor for and record unauthorized personnel and trespass.
